Manhole Inspection Summary

Manhole # S37WW_017MH

Location Address: **3005 GREENMOUNT AVE**

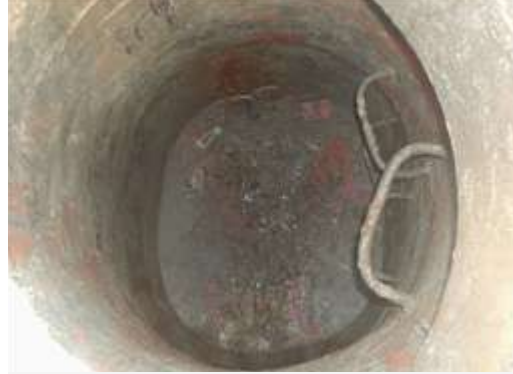
Top View

Barrel infiltration. Channel debris.

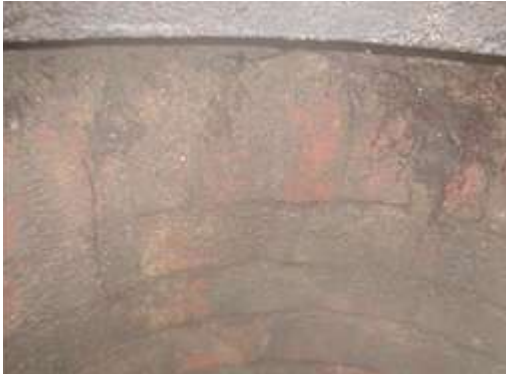
Defect

Frame leaks. Adjustment root intrusion and infiltration.

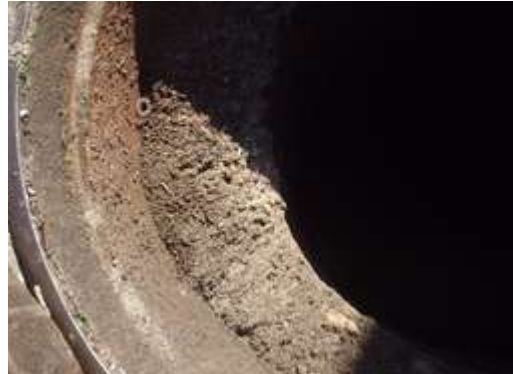
Defect

Frame leaks. Frame offset.

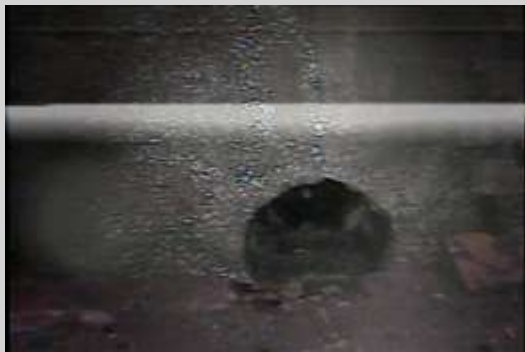
8 in. Circular Gravity Sewer
Pipe Out @ 12 O'Clock

Deposits: ☐ None ☒ **Mud** ☐ Sludge ☒ **Debris** ☐ Grease

Silt Depth: **2** (in.) Deposits Extent: **Light**
